Results of the Minnesota Suburban Lakes Nautical Archaeology 2 Project

Lake Johanna Project Results

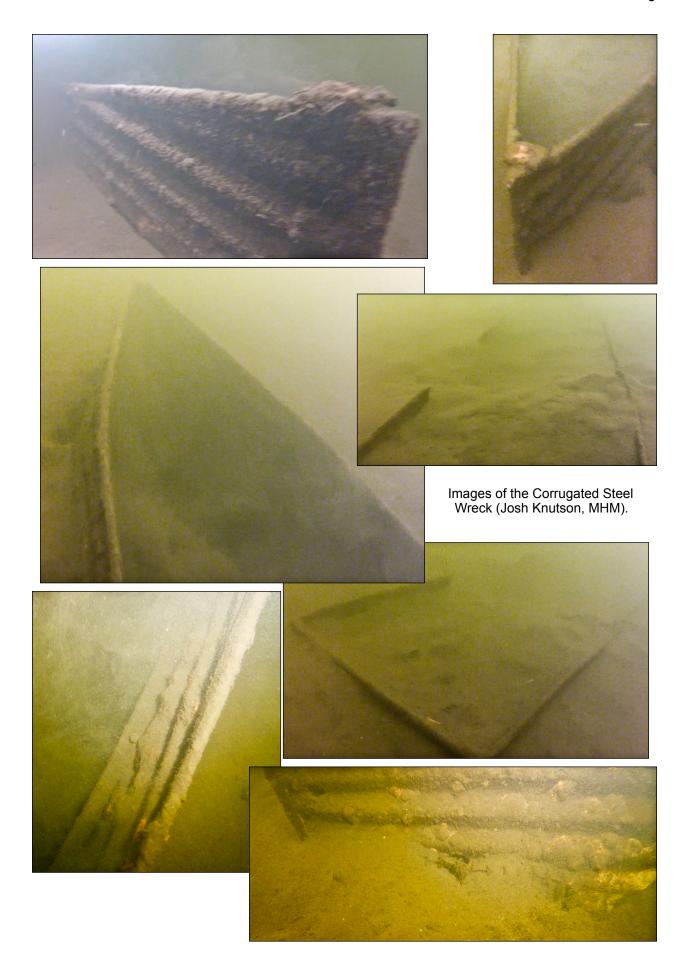
Corrugated Steel Wreck, 21-RA-83 (Anomaly 10)

The 2016 sonar images of Anomaly 10 indicated it was a wreck and the MSLNA-2 Project survey produced even clearer data of the site. The Corrugated Steel Wreck was identified in mid-October 2018. The hull is fabricated from corrugated steel and the wreck is 12.20 feet long and 3.20 feet in the beam amidships to the transom. The transom is square and the pointed bow has a stempost, and a small triangular metal sheet at gunwale level provides rigidity. The remains of a towing loop is seen on the metal sheet. An extruded steel caprail is attached to the gunwale. Anomaly 10 is siltedin and no seats can be seen or are evident, but the vessel likely had 3 of them at the time of construction. Along the inner starboard side hull where the silt has shifted and a longitudinal steel stringer can be seen near the turn of the bilge; the port side stringer can be seen at the bow. Further, steel frames are attached to the stringer and the inner hull on the starboard side, with futtocks visible on the port side through the silt. The hull is damaged on the port side amidships and small holes through the wreck can be seen on the port side bow. Speckles of white paint can be seen throughout the wreck, but it is particularly evident Also near the port bow near the silt line, white paint survives. There is no evidence that the boat ever had a Minnesota registration number, indicating she sank prior to July 1, 1959. MHM contends Anomaly 10 is a Minnesota-built boat and
